Evaluation of Corrosion Inhibitors

FINAL REPORT
October 1999

Center for Advanced Infrastructure & Transportation (CAIT)
Civil & Environmental Engineering
Rutgers, The State University
Piscataway, NJ 08854-8014

New Jersey
Department of Transportation
Division of Research and Technology
and
U.S. Department of Transportation
Federal Highway Administration

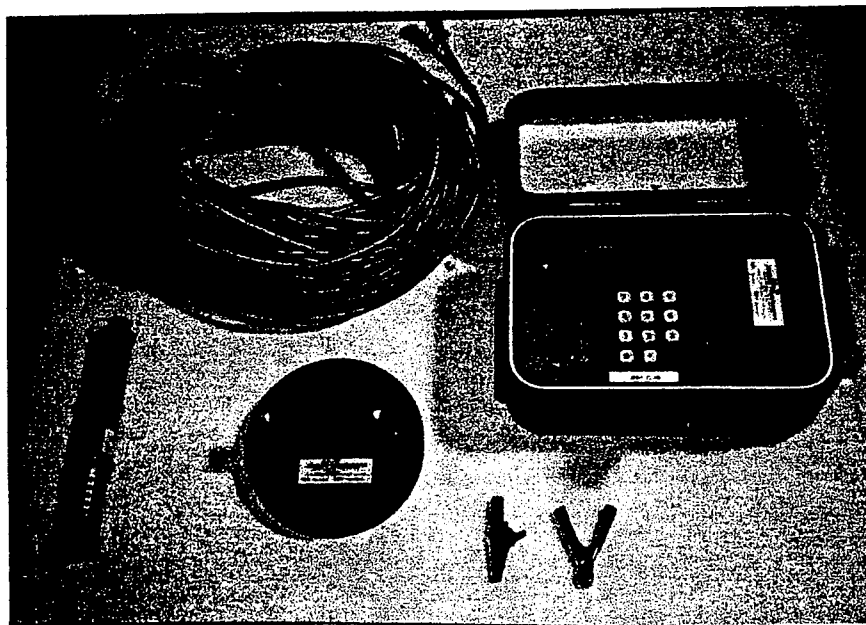
Fig. 3.1: Components of the GECOR 6 Corrosion Rate Meter

The GECOR 6 Corrosion Rate Meter has three major components, the rate meter and two separate sensors. Only the larger sensor was used during this project. The sensor is filled with a saturated Cu/CuSO_4 solution for the test for half cell potential. The main components of this device can be seen in Fig. 3.1. A wet sponge is used between the probe and the concrete surface as seen in Fig. 3.2. Long lengths of wire are also provided to connect the sensor to the rate meter and to connect the rate meter to the reinforcing bar mat of the bridge deck, a necessary step for the operation of the meter.

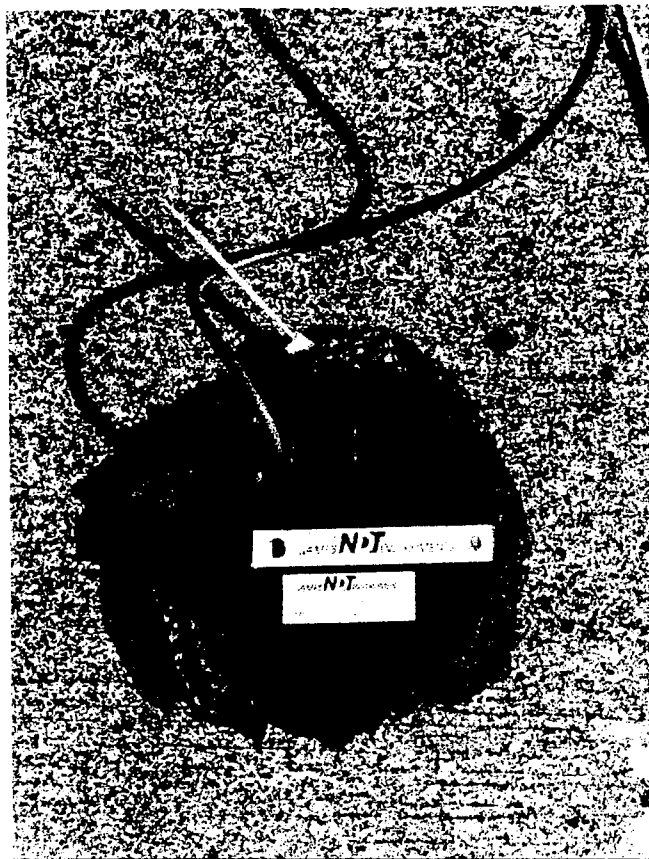
Fig. 3.2: GECOR 6 Corrosion Rate Meter Sensor with Sponge
